KENNEDY DAM

PHASE I INSPECTION REPORT NATIONAL DAM SAFETY PROGRAM

SEPTEMBER 1979

Date of Inspection: 26 June 1979

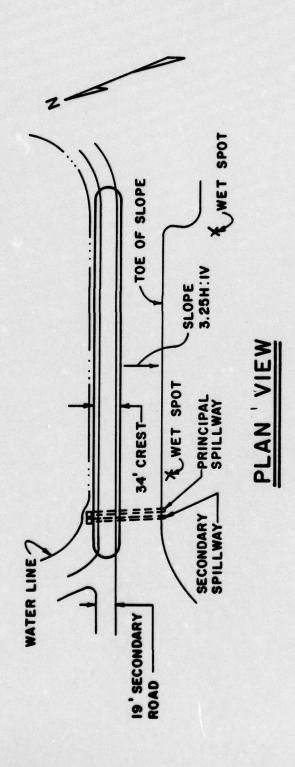
PLATE II

- 3.1.2 Dam: The general soil conditions were dry. The embankment was in good condition, but the downstream slope was vegetated with brush. The upstream slope along the crest was sparsely vegetated with up to 12-inch diameter trees. The crest of the dam served as a paved secondary road, Appendix II, Photo 1. The upstream right abutment junction has eroded due to surface runoff, Appendix II, Photo 6. No settlement, misalignment, or sloughing were noted. Two wet spots were found in the downstream area as shown in Plate II, Appendix I. No foundation drain outlets were located.

TYPICAL CROSS SECTION

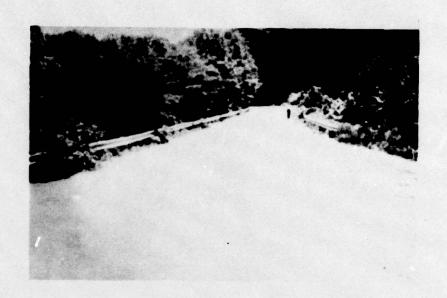
PHOTO #1 CREST OF DAM
